LAKE ROBERT ROOKE DAM

PHASE I INSPECTION REPORT NATIONAL DAM SAFETY PROGRAM

REPT. NO. DAEN/NAP - 53842 / NJ00262 - 81/08

MARCH 1981

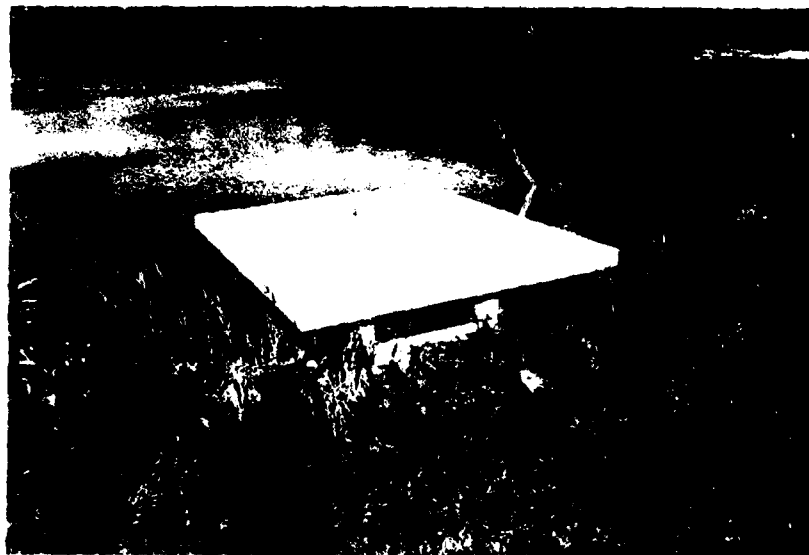
Top of drop inlet spillway.
